Client:	-	OVERALL	Donding
Report number:	FBX-05-2023-41306	RESULT	Pending
Inspection Date:	2023-05-14	Page 1 of 30

Client:	-
Supplier:	-
Factory:	-
Product Name:	bamboo
P.O.#./P.I.#:	Inspection for Fullbax   -
item#:	26-28mm, 28-30mm
Order Quantity:	1165 Pcs/sets
Finished Quantity:	1165 Pcs/sets   In 100.00 %
Inspected pieces:	80 Pcs/sets
Destination country:	Poland
Re-Inspection:	YES NO
Reference for inspection:	Approval sample Product Specification PO. PI. Packaging spec. SOP:WINS-SOP-B334_V1.9

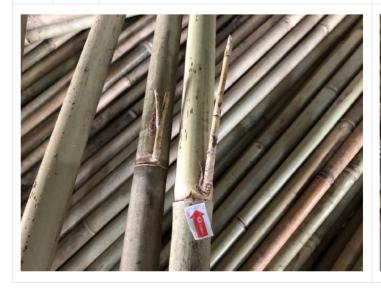
Damage mark on end (9cm, 1pc); Scarring marks (0.8x5cm, 1pc); Untreated branches (2pcs) Major Item# 26-28mm Damage mark on end (9cm, 1pc); Scarring marks (0.8x5cm, 1pc); Untreated branches (2pcs) Major Item# 26-28mm

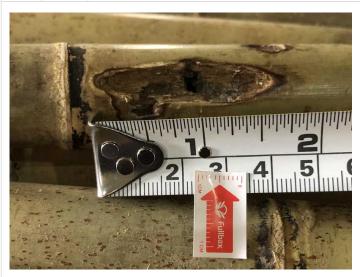
4↓ Crack mark on surface (30cm, 1pc); Scarring marks (1x4cm, 1pc); Curved Bamboo(1pc). Major Item# 26-28mm

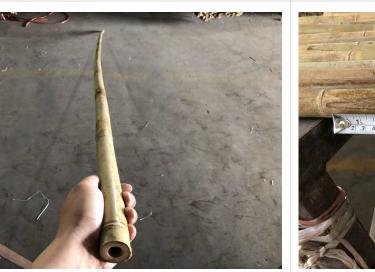
5↓

Damage mark on surface (2x26cm, 1pc); Crack

mark on surface (2pcs: length 36-45cm).

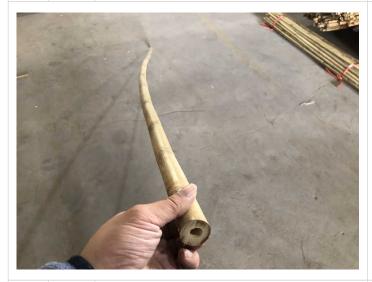
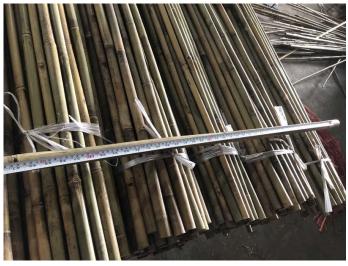
- Bamboo knot spacing more than 40cm (3pcs);Curved Bamboo(1pc).N°Major Item# 28-30mm11↓
- Bamboo knot spacing more than 40cm (3pcs); Curved Bamboo(1pc). Major Item# 28-30mm

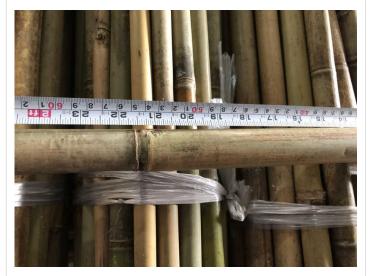
N° 11↓

Bamboo knot spacing more than 40cm (3pcs); Curved Bamboo(1pc). Major Item# 28-30mm

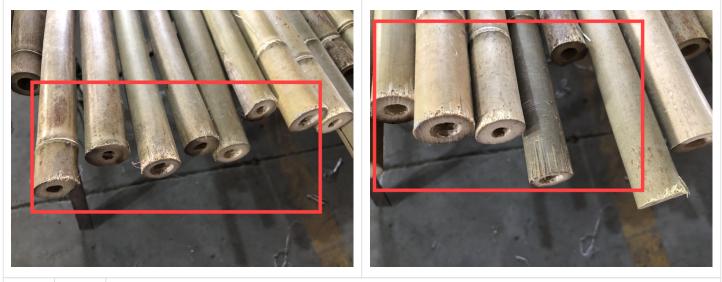
SPA / OBS PICTURES					
SPA #	2↓	Pending due to 100% fragments burrs on both ends of bamboo pole for all items.

Pending due to 100% fragments burrs on both ends of bamboo pole for all items.

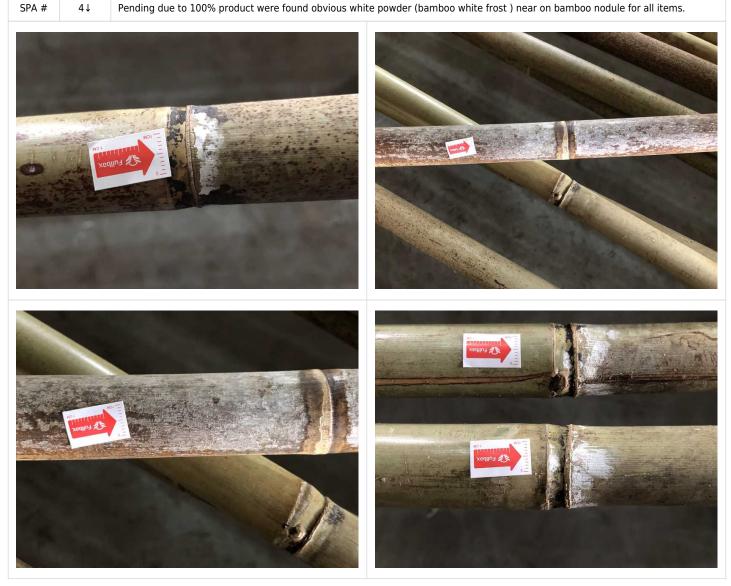
SPA #

Pending due to 100% product were found obvious white powder (bamboo white frost ) near on bamboo nodule for all items.
