Pre-shipment Inspection Report

No.: SGF-20201030-08GZ

Product Name	Q235 metal sheets
Model number	2mm, 3mm
P/O number	lys220311
Quantity	42tons
Client name	N/A
Supplier name	N/A
Inspection date	Mar 26th , 2022
Arrival time	9:30
Departure time	12:00
Inspection location	FENGNAN
Inspector	VIVIAN
Supervisor	William

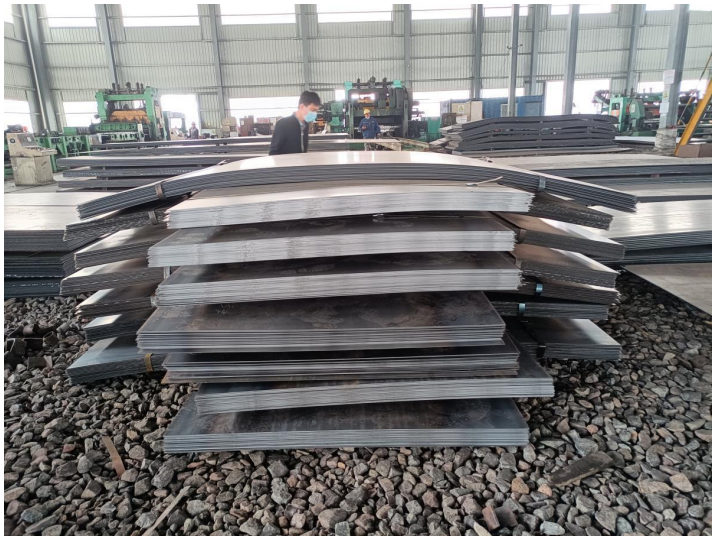
Finished products storage

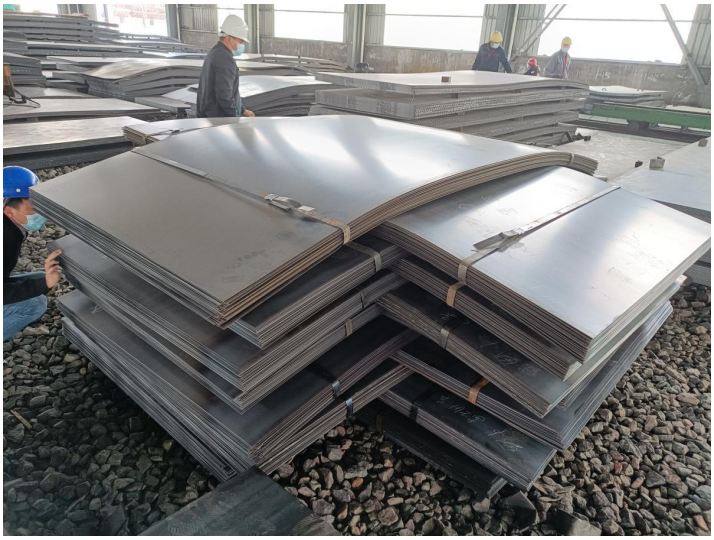
Product details	**Product details**
Product details	**Product details**

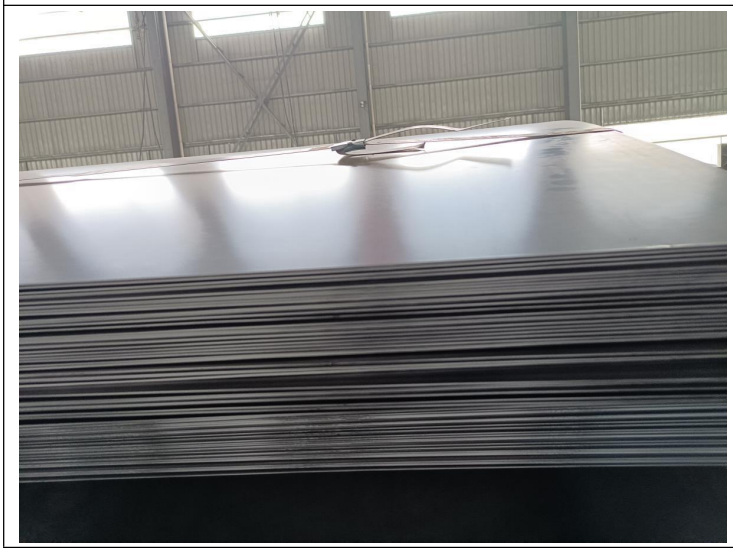
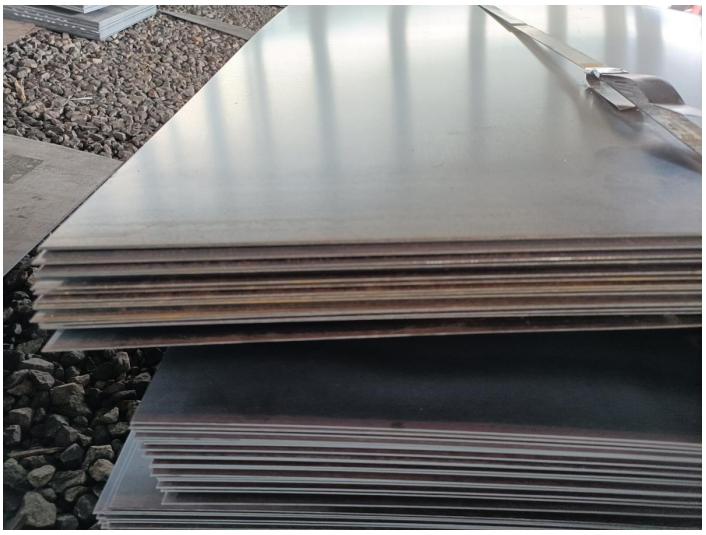
Product details	Product details

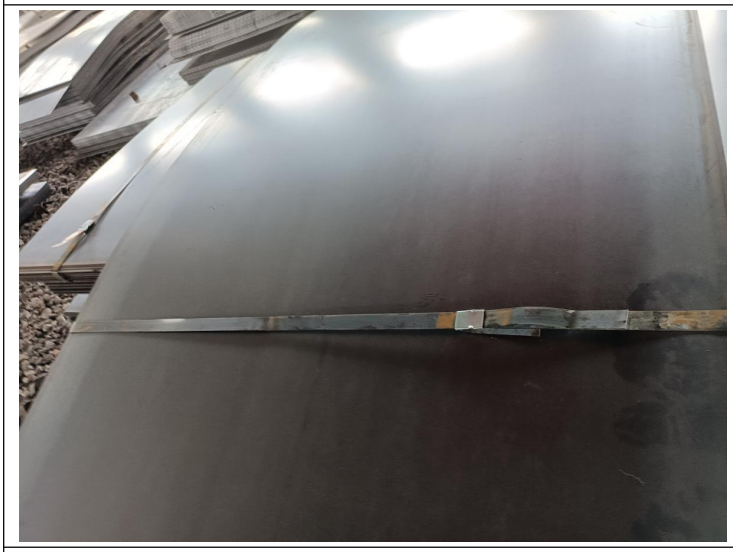
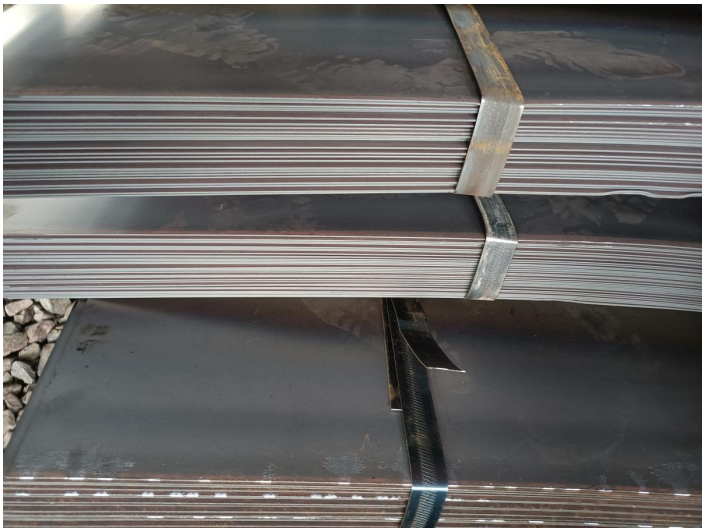
Product details	**Product details**
Product size	**Product size**

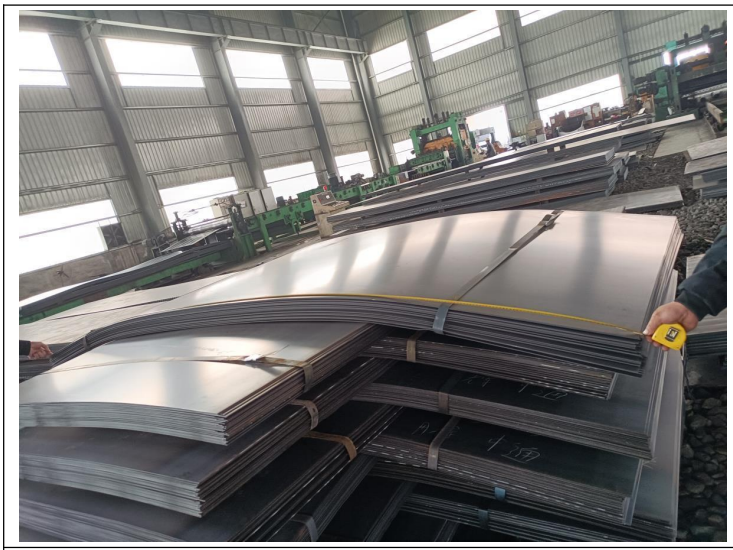
Product size	**Product size**

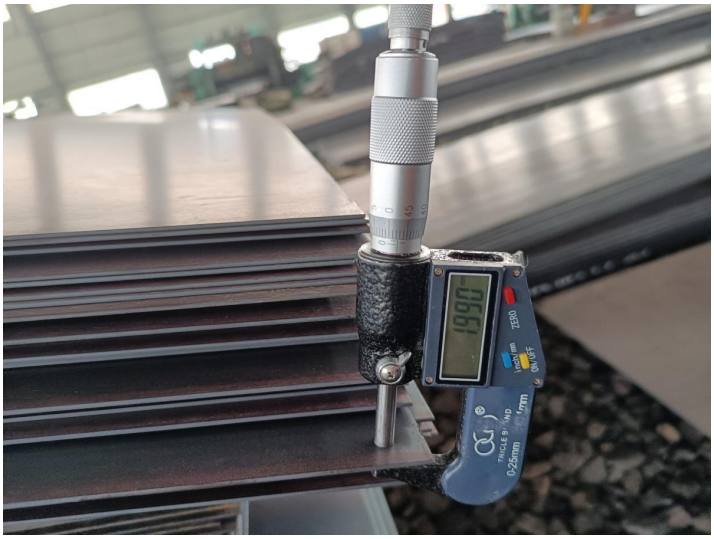
Product size	**Product size**
ITEM: 3mm*1500*3000
